# DELIVERY SUPPORT REPORT

GR-DS-2026-014 | Page 1 of 2

**PROJECT**  
**Brickell Office Refresh**

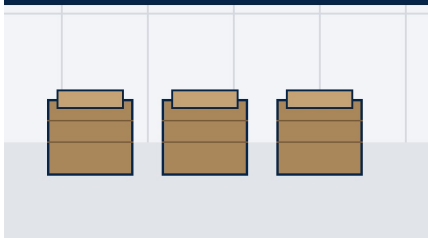
01 DELIVERY ARRIVAL

Carrier arrival at Dock B

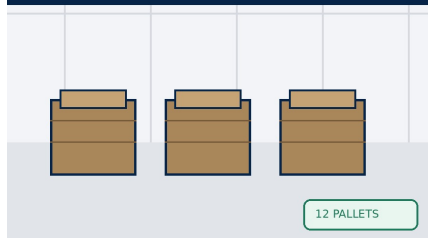
02 PALLET COUNT

12 pallets observed after unload

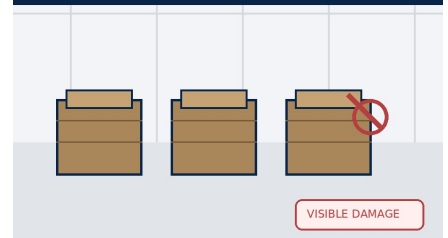
03 DAMAGE DOCUMENTATION

Pallet #07: crushed corner / torn wrap

Outer carton and stretch wrap showed a crushed lower-right corner at the time of unloading. No internal condition was assessed. The condition was photographed and relayed to the client for review.

- 1 Review pallet #07 photos.
- 2 Confirm whether carrier claim is required.
- 3 Confirm disposition before installation.

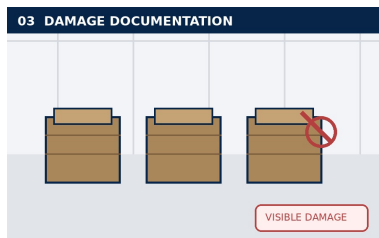
03. Pallet #07 - visible exterior damage

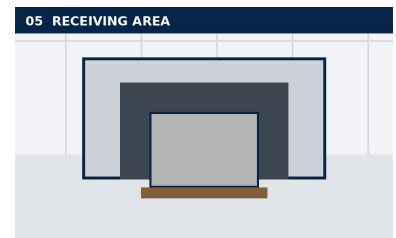
05. Receiving area after unload
